## CAFO WPDES Compliance Report (6-20-14)

Inspection date: 4-25-14

Operation Name: Dairyland Farms LLC

WPDES Permit No. WI-0059559-03-0

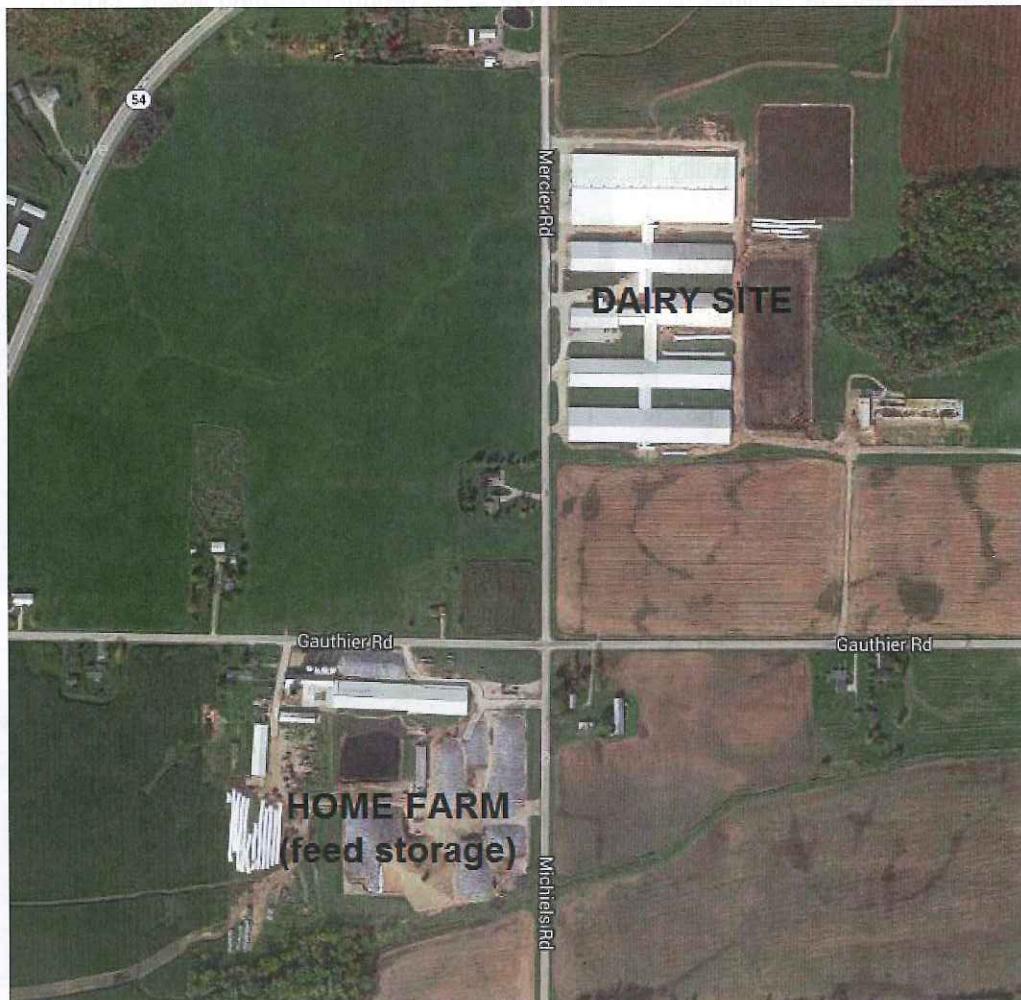
Photo 1: Site location of Dairyland Farms—consists of Main Dairy site where most cattle are housed and Home Farm that has feed storage.

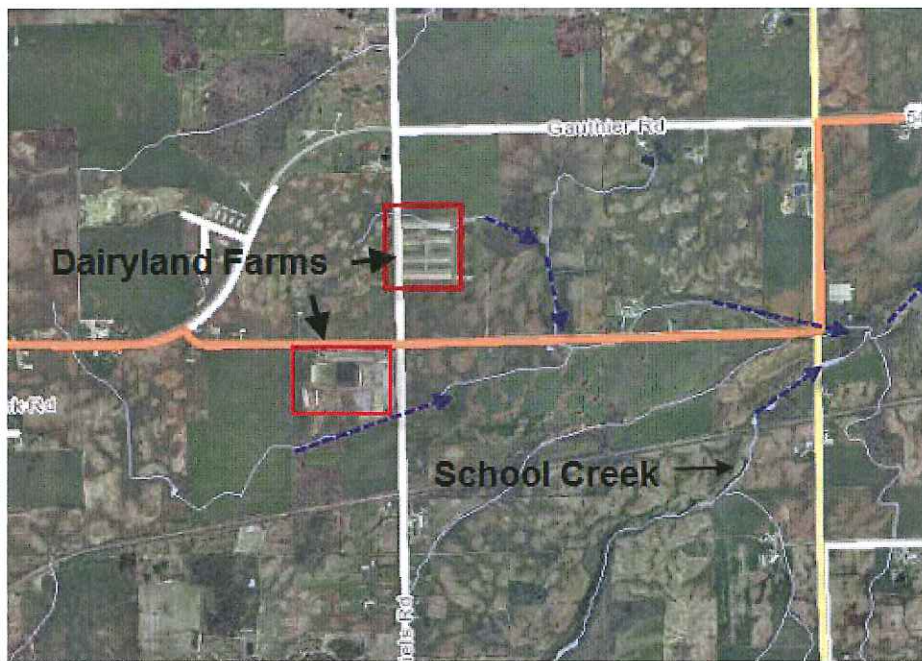
Photo 2: Overview of farm and stream locations. Drainage from both sites go into stream tributaries of School Creek.

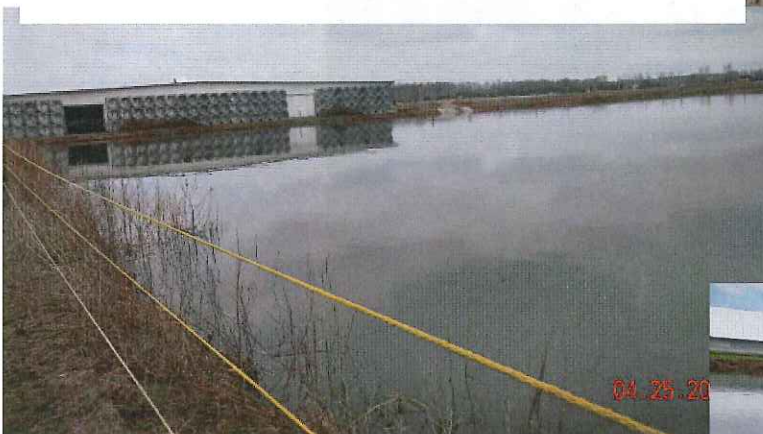
At time of inspection all three waste storage facilities were close to or at maximum operating levels. Due to time of year and weather conditions this was to be expected. There were some bedded pack and digested manure solids stacked at the Main Dairy site that had potential for discharging into nearby storm water flow paths.

Photo 3 (right): Looking north at waste storage facility 1.

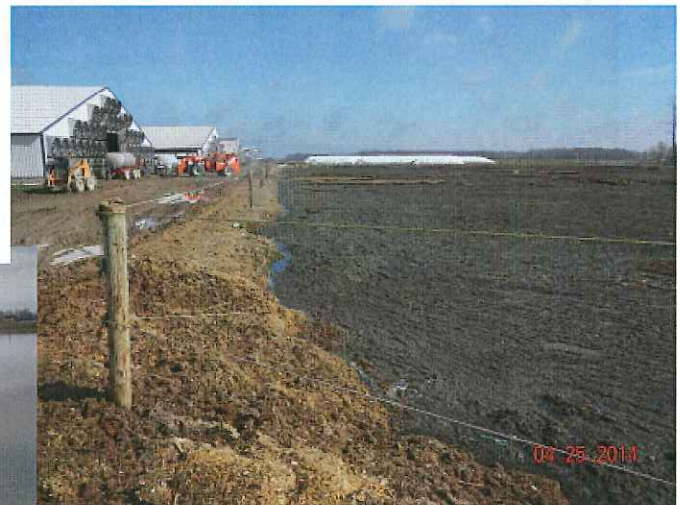
Photo 4 (below): Looking northwest at waste storage facility 2.

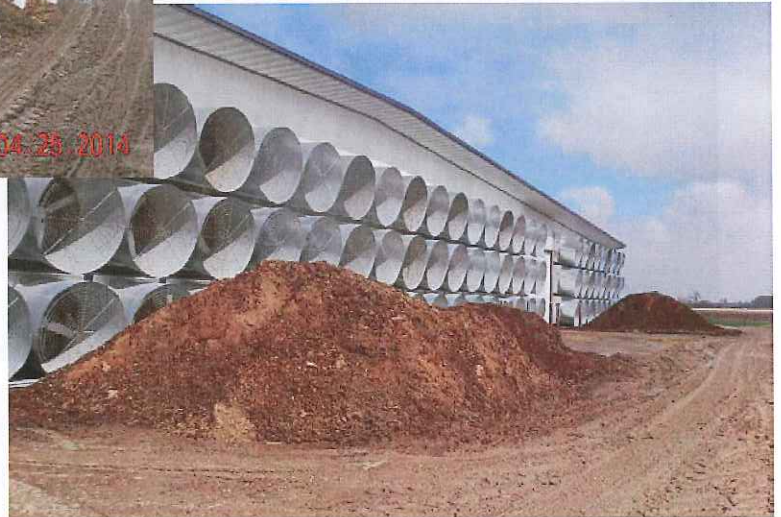
Photos 6 and 7: Views of solid manure/waste feed piles at Main Dairy site.

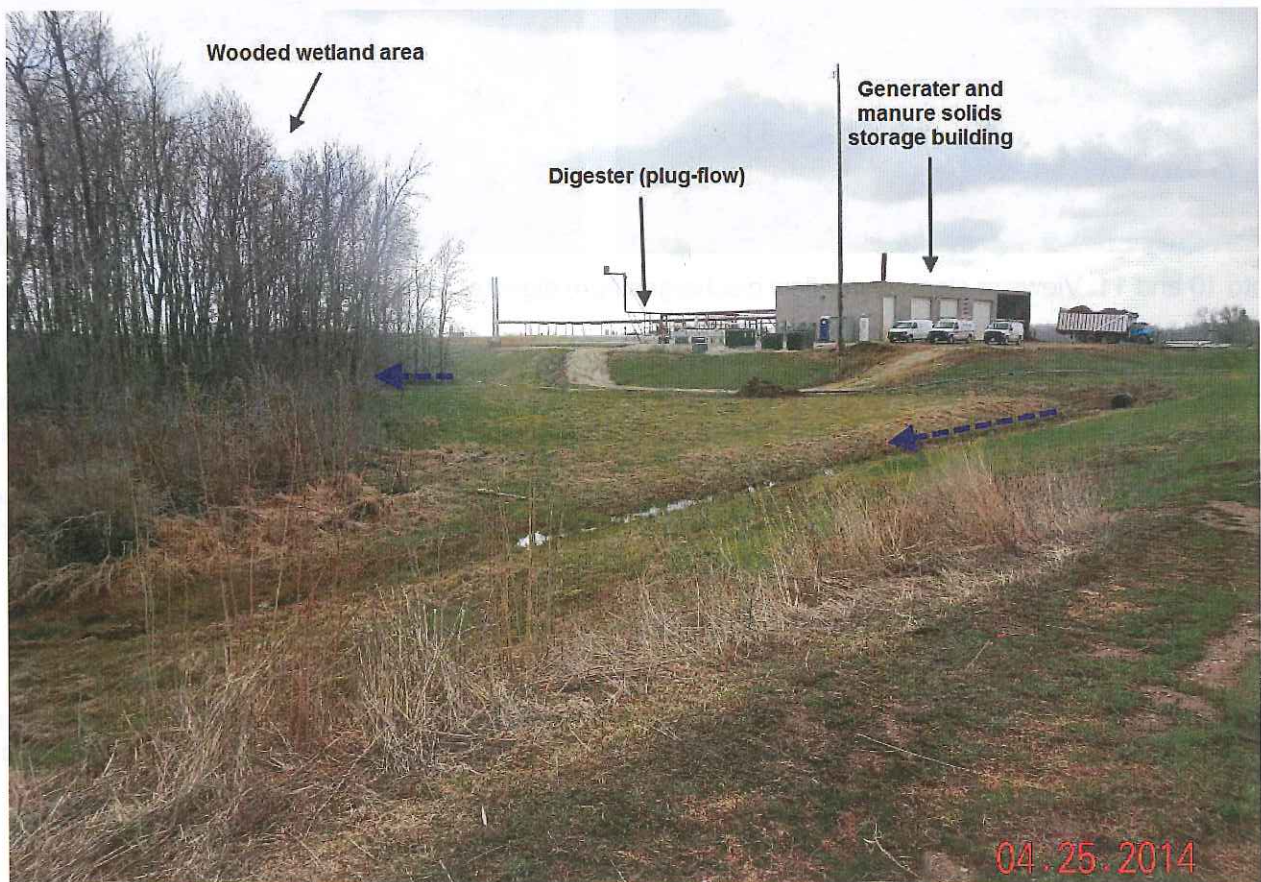
Dairyland Farms has a digester facility located in the southeast corner of the Main Dairy production site. Only issue noted in this area are some wind-blown digested solids that may get into the storm water flow paths.

Photo 8: Looking southeast at digester area. Blue arrows showing storm water flow paths.

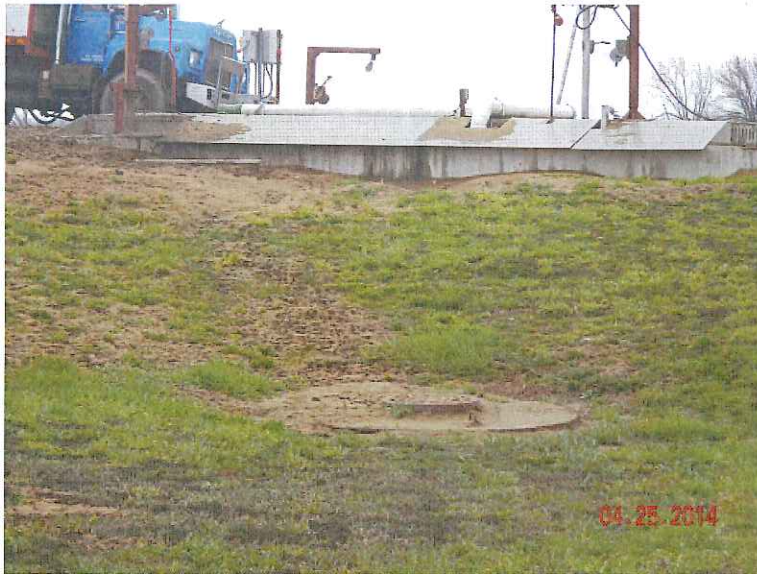
Photo 9 (left): View of wind-blown digested manure solids near storm water manhole.

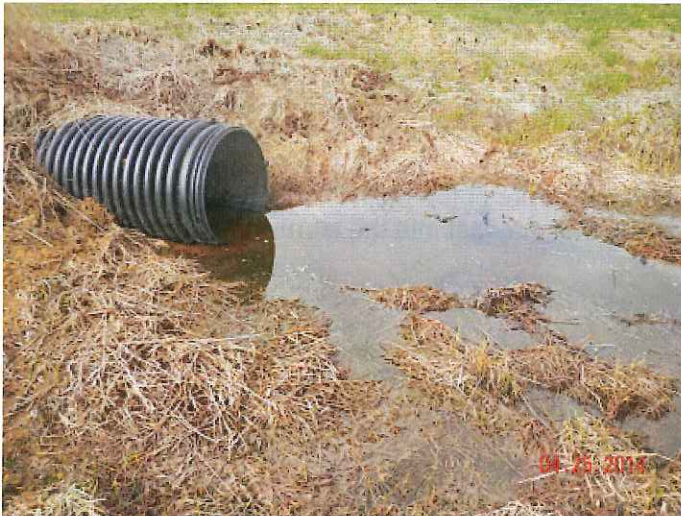
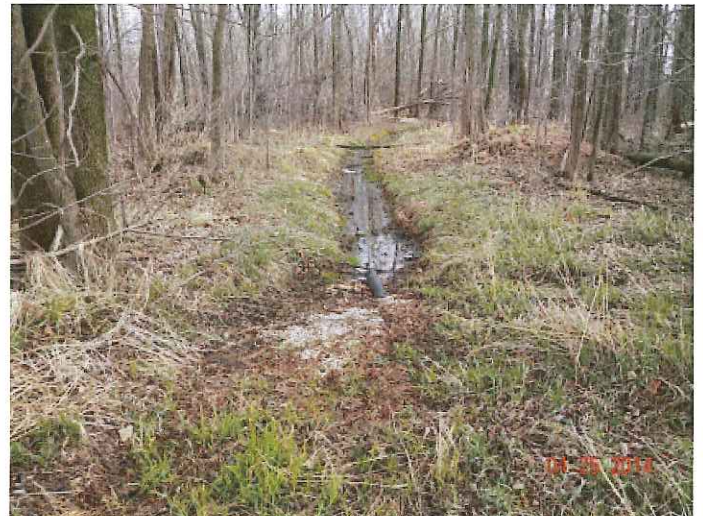
Photo 10 and 11: Views of storm water flow discharges from digester area. Water was fairly clear in both areas.

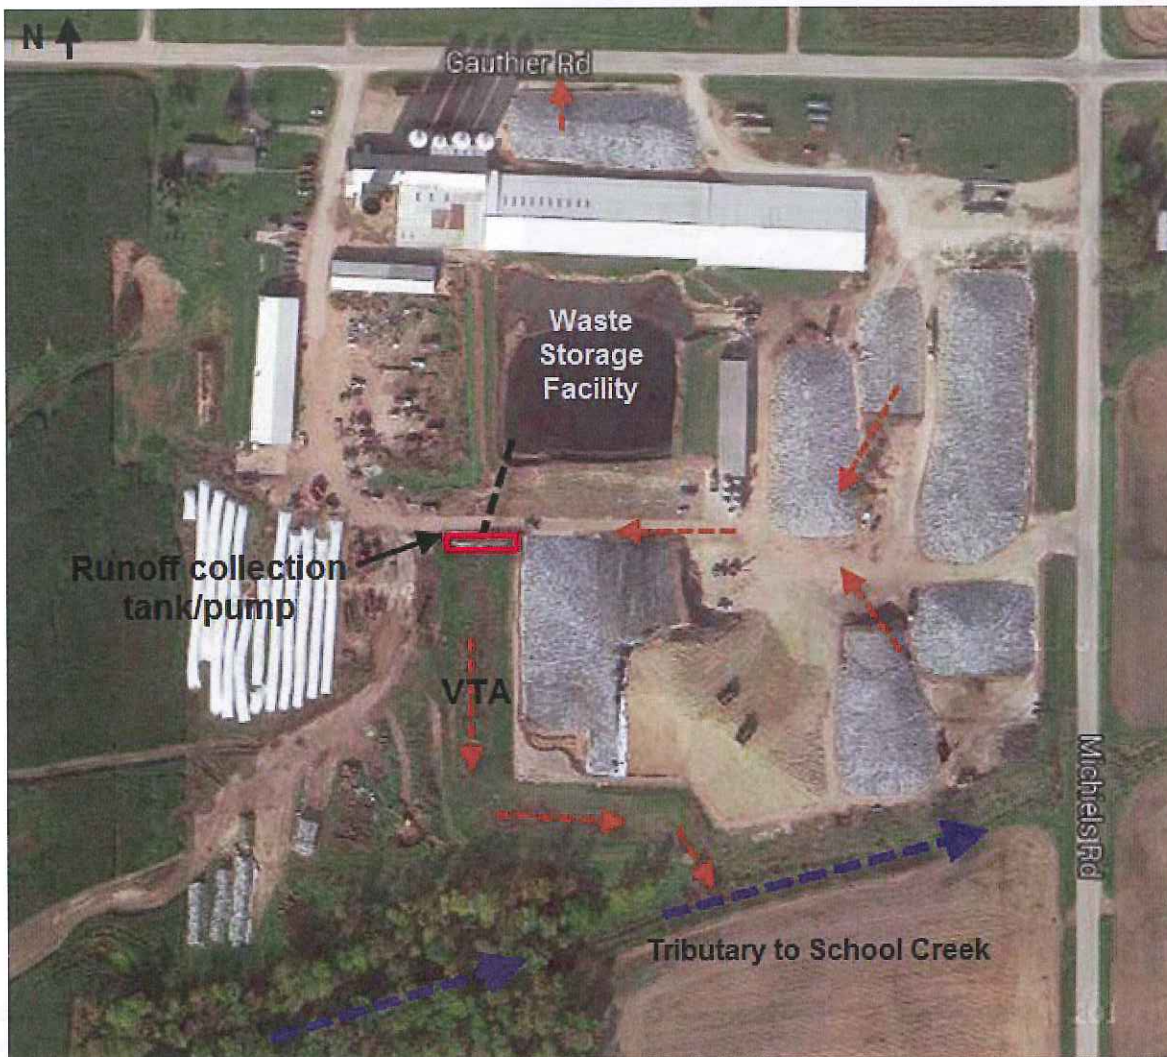
Photo 12 (above): Overview of Home Farm site.

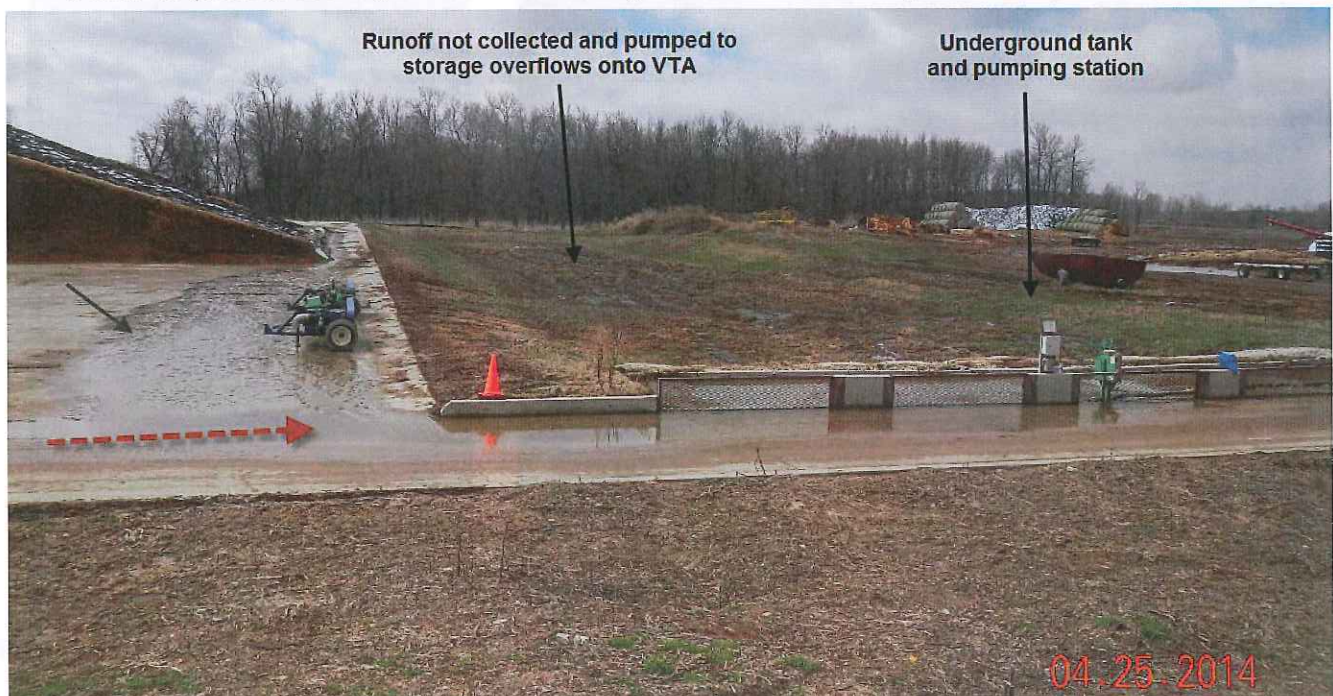
Dairyland Farms has large feed storage area located at the Home Farm site. Feed is stored in large piles on a concrete pad—primary feed types are corn silage, haylage and high moisture corn. A runoff control system is in place but does not appear adequate due to the size of the feed storage area and proximity to stream tributary. The inspection revealed that discharges from end of vegetated treatment area (VTA) are occurring into stream tributary. A temporary containment berm is in place but based on site observations, not all ponded runoff within VTA is being pumped back to waste storage.

Photo 13 (below): Looking south at feed storage area runoff control system.

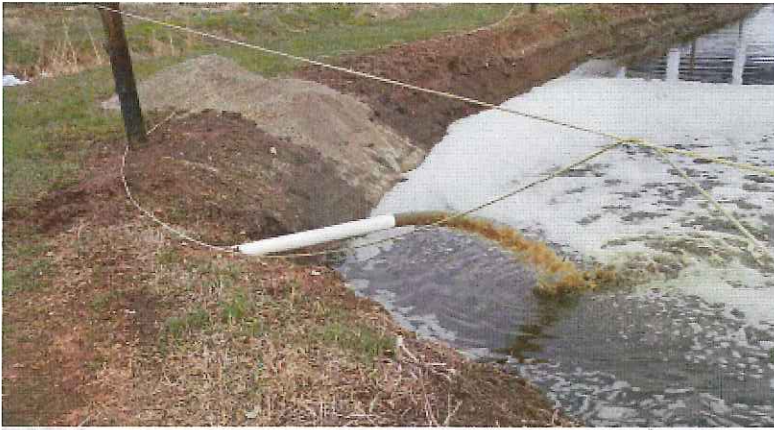
Photo 14: View of feed storage runoff water being pumped into waste storage facility.

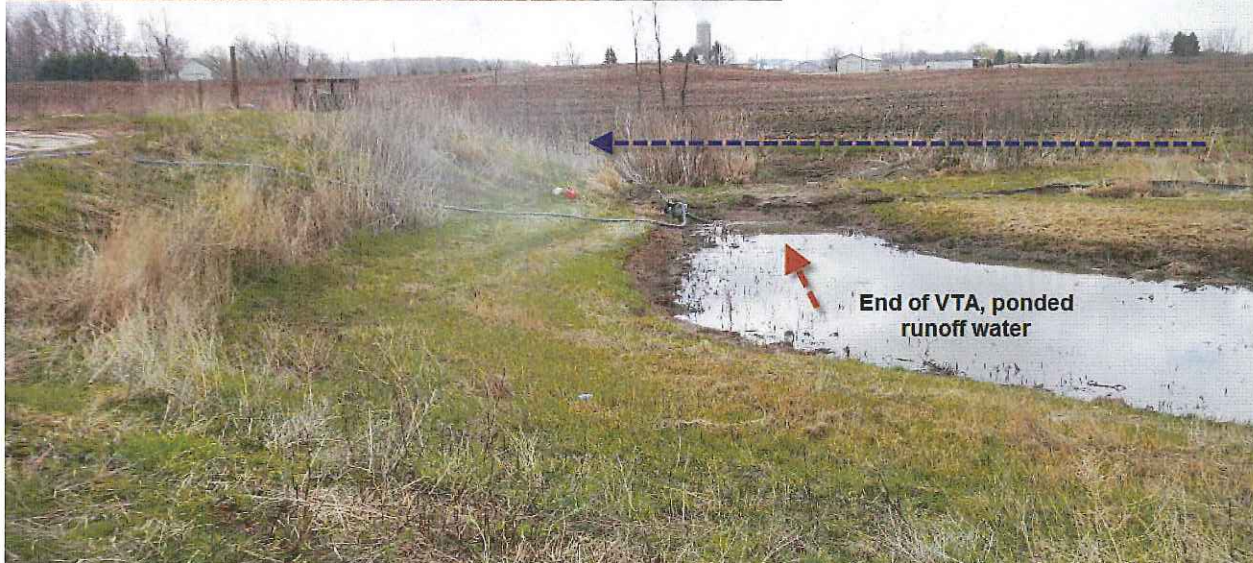
Photo 15: Looking south at end of vegetated treatment area. An earthen berm was present at end prior to stream location (blue arrow). A temporary pump was pumping runoff water onto feed pad which flows toward runoff collection system tank and pump.

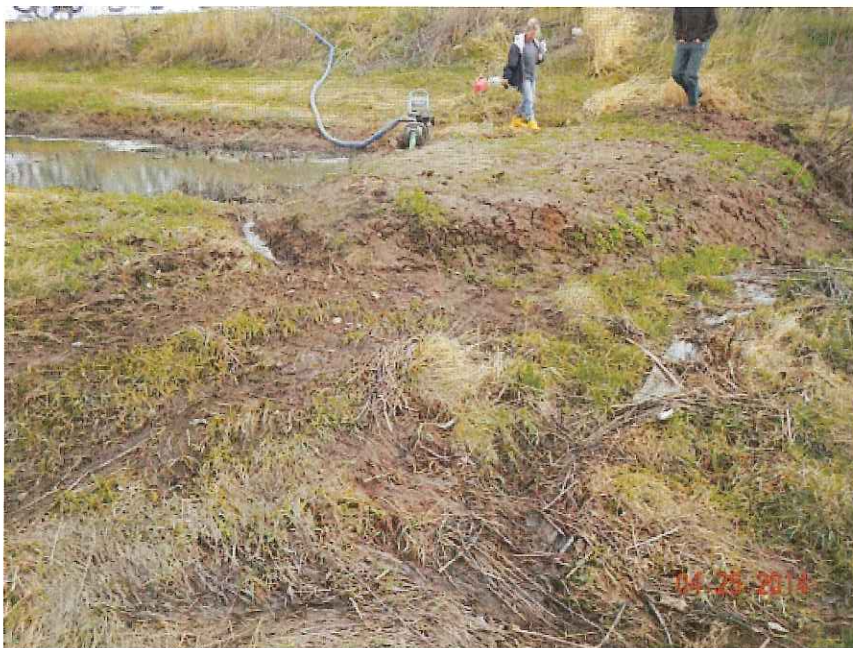
Photo 16 (above): Close view of earthen containment berm. Small eroded channel in berm is present where runoff water has likely overflowed berm and discharged to stream.  
 Photo 17 (right): View of ditch south of berm leading to stream. Water had slight sheen and discoloration indicative of leachate runoff.

- Increase height of temporary containment berm, pump regularly and do not let any runoff water discharge to stream.
- Stop any discharges from silage bag storage areas. Discontinue use of bags unless approved by DNR.
- Consult with engineer on design options for upgrades in runoff control system.
- Consult with engineer on design for necessary replacement of cracked concrete feed pad areas.
- Remove and discontinue any stacks of waste feed, bed pack or digested manure solid at production sites where runoff is not contained.
- Install permanent feed storage control measures to address discharge problems.

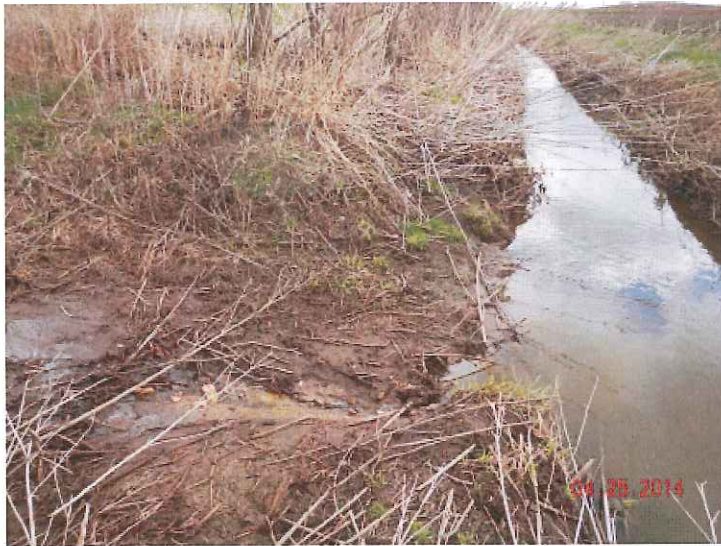
Photo 18 (left): Looking east at discharge point from end of VTA into stream tributary.

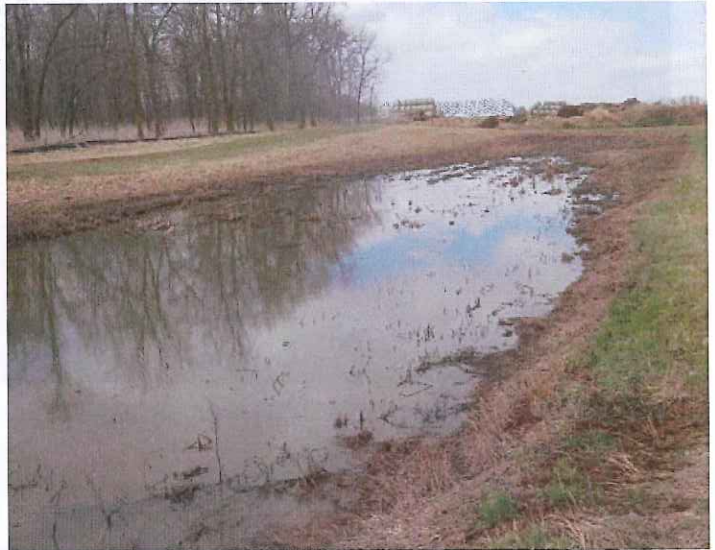
Photo 19 (right): View of dark murky runoff water ponded at end of VTA. If not pumped with temporary pump, polluted water discharges directly to stream.

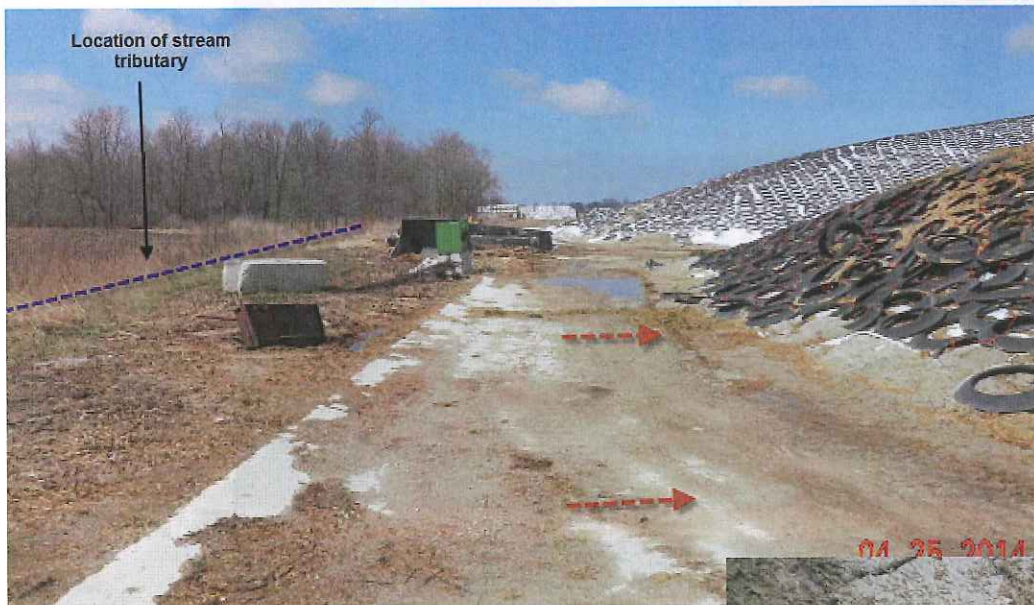
Photo 20: Looking west at southern edge of feed pad, no obvious signs of runoff discharging to stream in this area. Concrete pad is pitched toward north to direct leachate to runoff collection system.

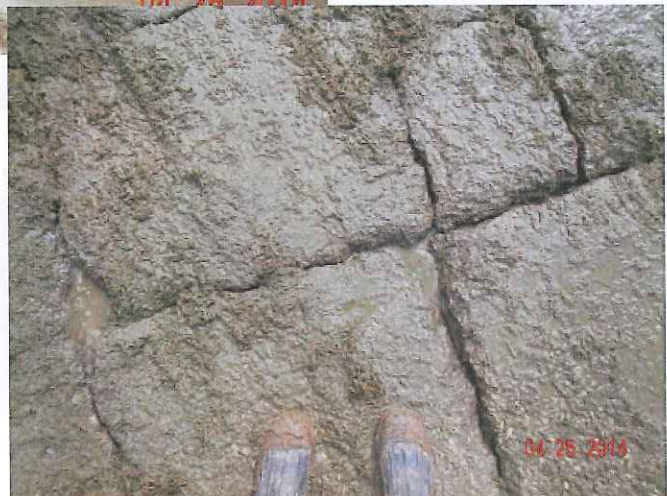
Photo 21: Close view of large cracks in feed pad. Several areas need maintenance/replacement.

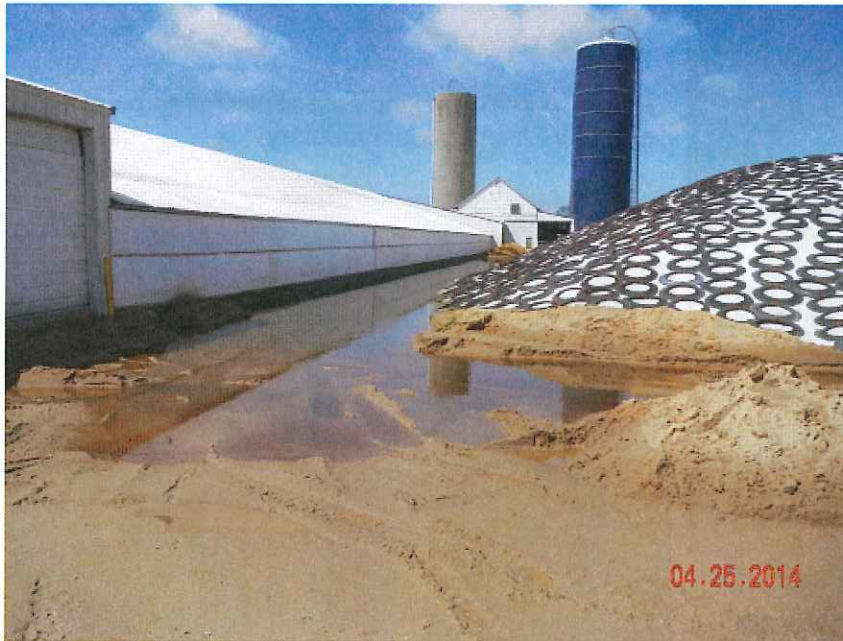
Photo 22: Looking west at haylage storage on north side of barn—there is no runoff collection for this area. Use must be discontinued as runoff is discharging into road ditch.

Feed stored on north end of barn at Home Farm must be fed out as soon as possible and abandoned permanently.

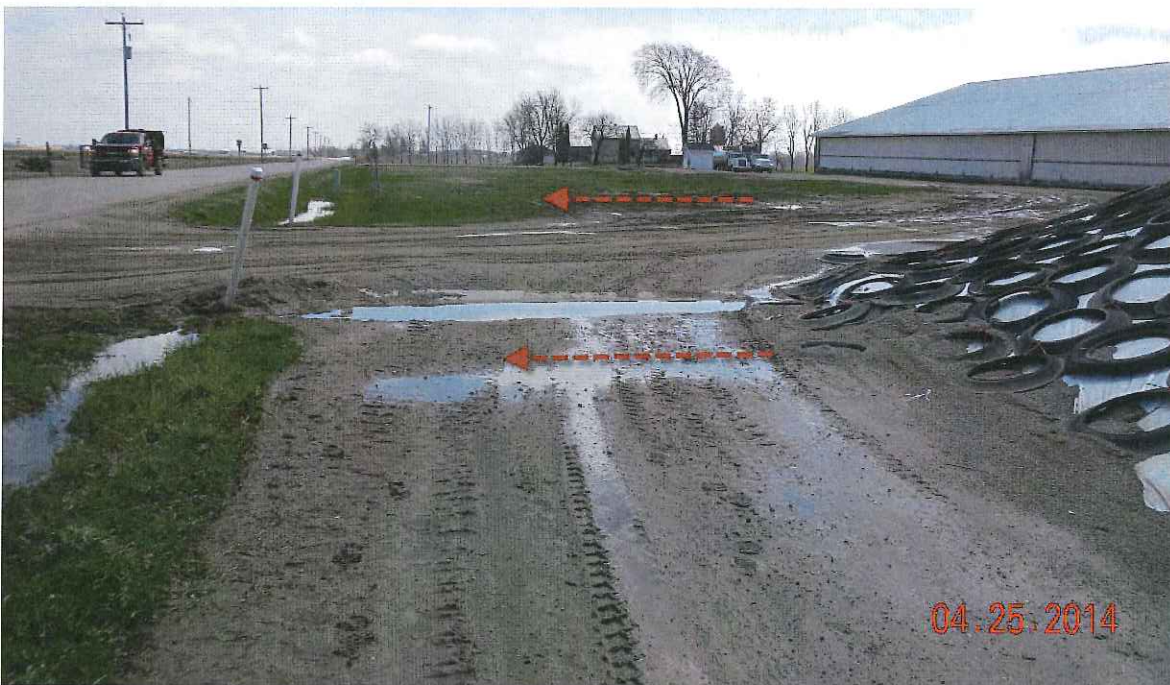
Photo 23 (below): Looking east at discharge flow path.

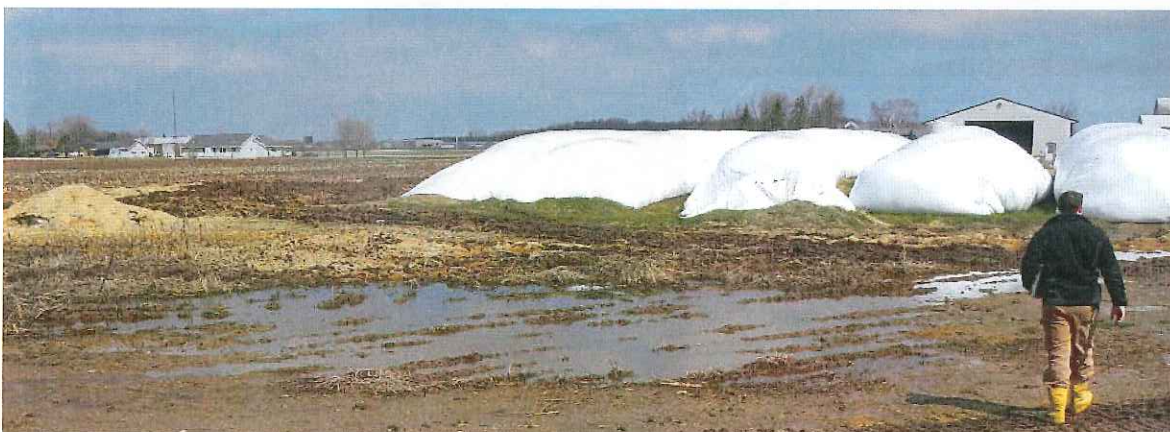
Photo 24: View of silage bags located in southwestern corner of Home Site.

Dairyland Farms also uses silage bags, better location and housekeeping practices need to be proposed and approved by DNR. A discharge of silage leachate was occurring at Dairy site from silage bag into storm water ditch.

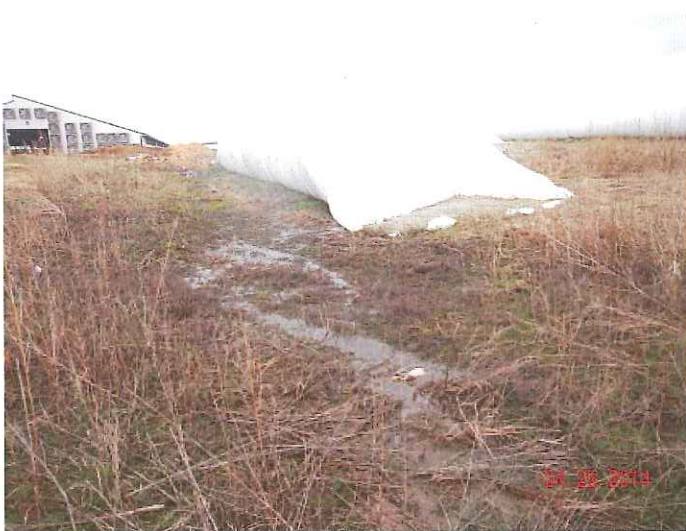
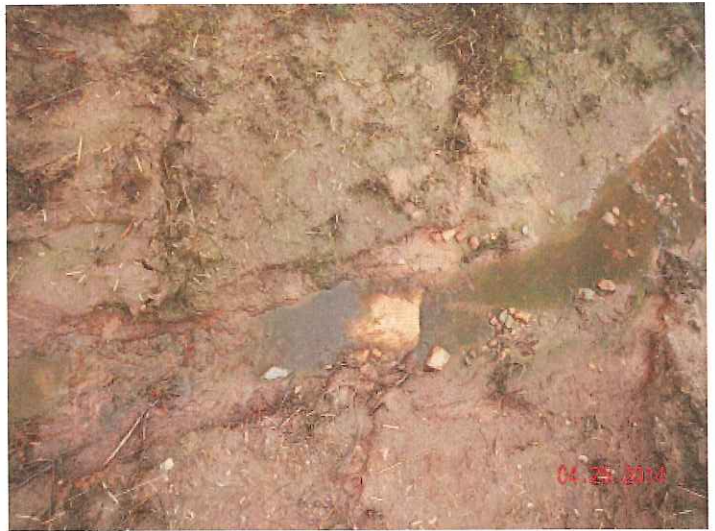
Photo 25 and 26: Views of silage bag discharge at Dairy Site.

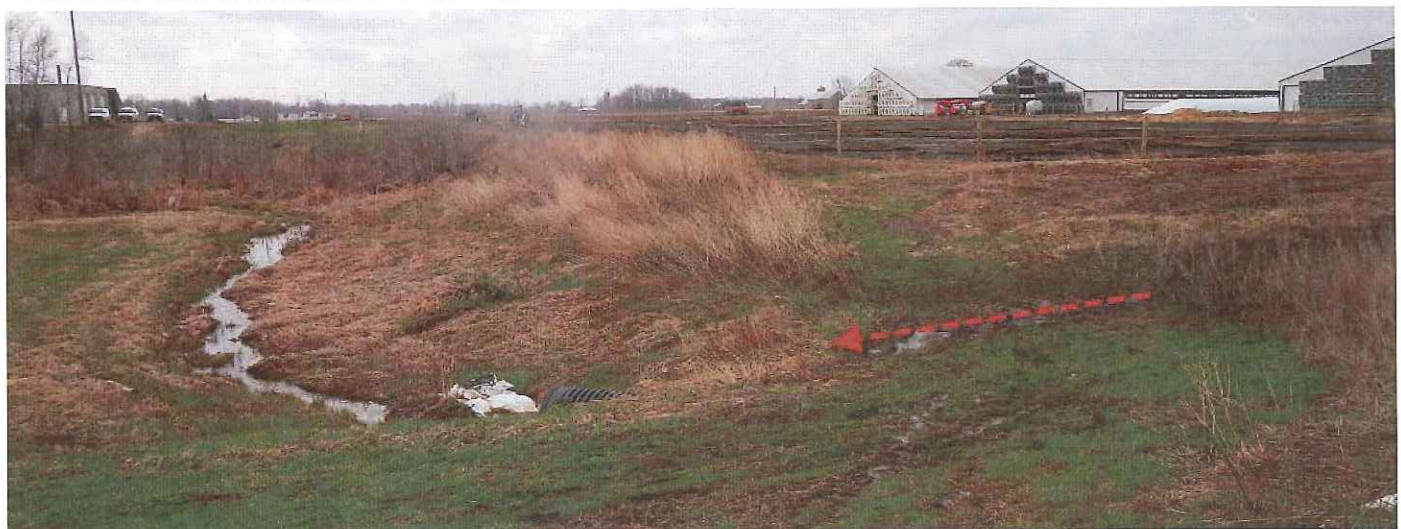
Photo 27: View of flow path of silage bag leachate into storm water ditch that discharges to stream tributary.
